MV FREMANTLE EXPRESS

Fatality during mooring operation

Veracruz (Mexico)

15 July 2011

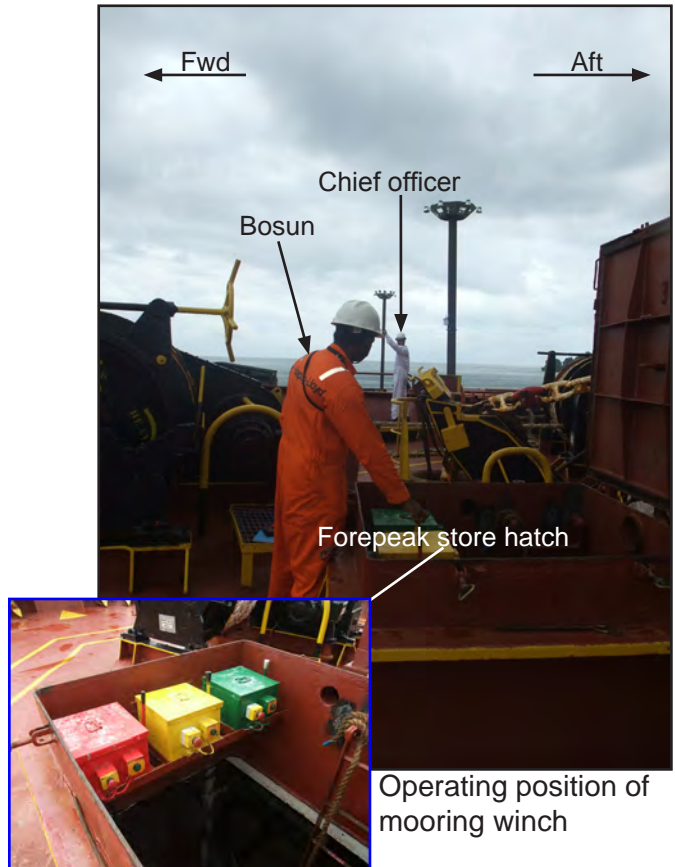
Figure 1

At 0942, the vessel approached her intended berth assisted by the two tugs, and the aft backspring was sent ashore. At 0944, the master instructed the chief officer to send the forward lines ashore. The cadet was tasked with throwing a heaving line to the mooring gang ashore while the trainee seaman and Shiva tended the lines. The bosun, facing aft, operated the winch controllers and took instructions from the chief officer who was standing on the starboard observation platform (**Figure 1**).

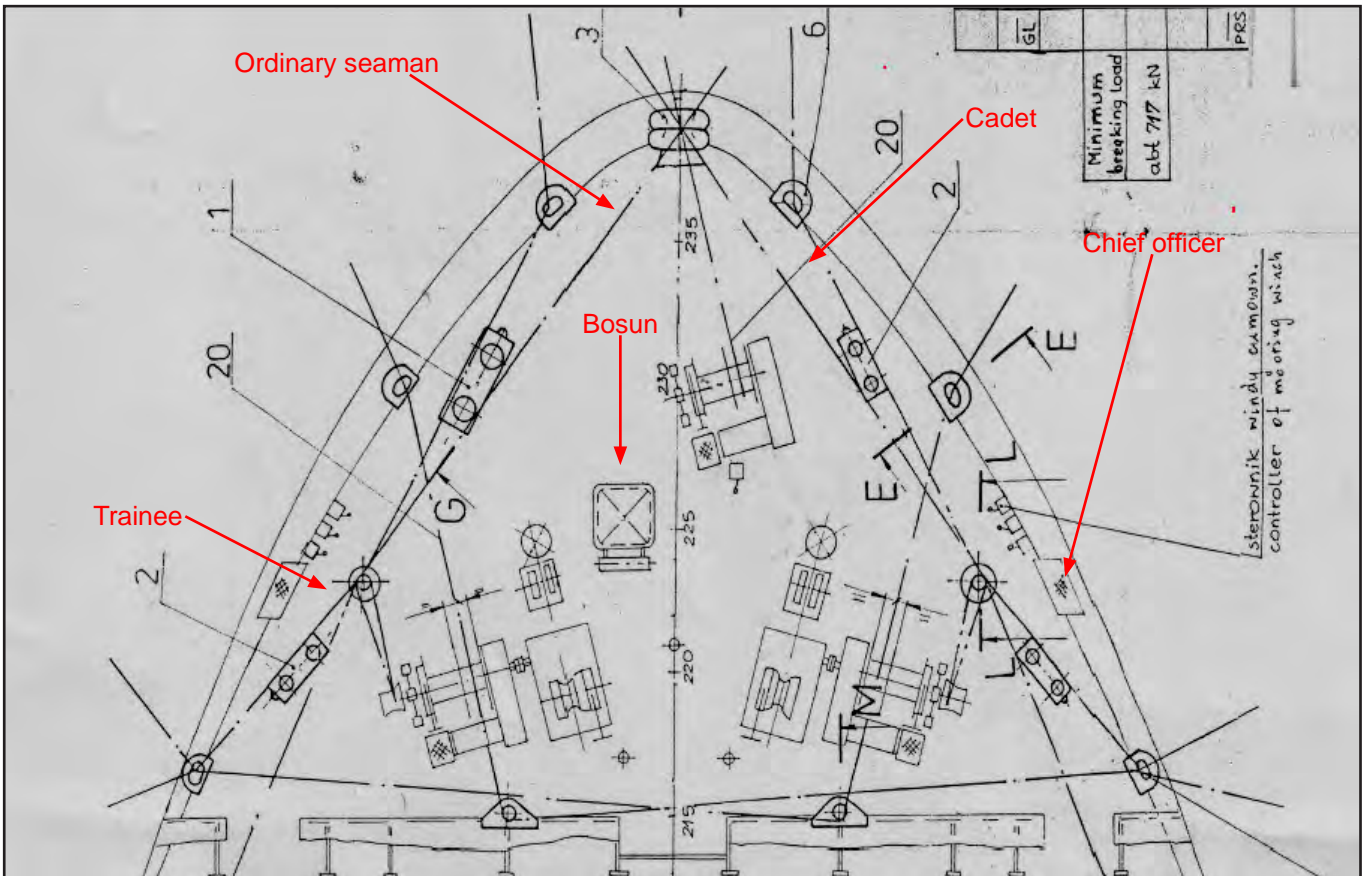
Figure 2

At 0945, the master instructed the second officer not to heave in the slack in the aft lines that had been sent ashore as the vessel was required to move 10 metres astern. At 0946, the trainee seaman and Shiva passed a forward backspring ashore from the starboard winch drum (**Figure 2**) and then passed a headline from the centre mooring winch through the centreline fairlead. At 0947, the master instructed the second officer to check the aft backspring as the vessel had now

General layout of the forward mooring station and mooring arrangements

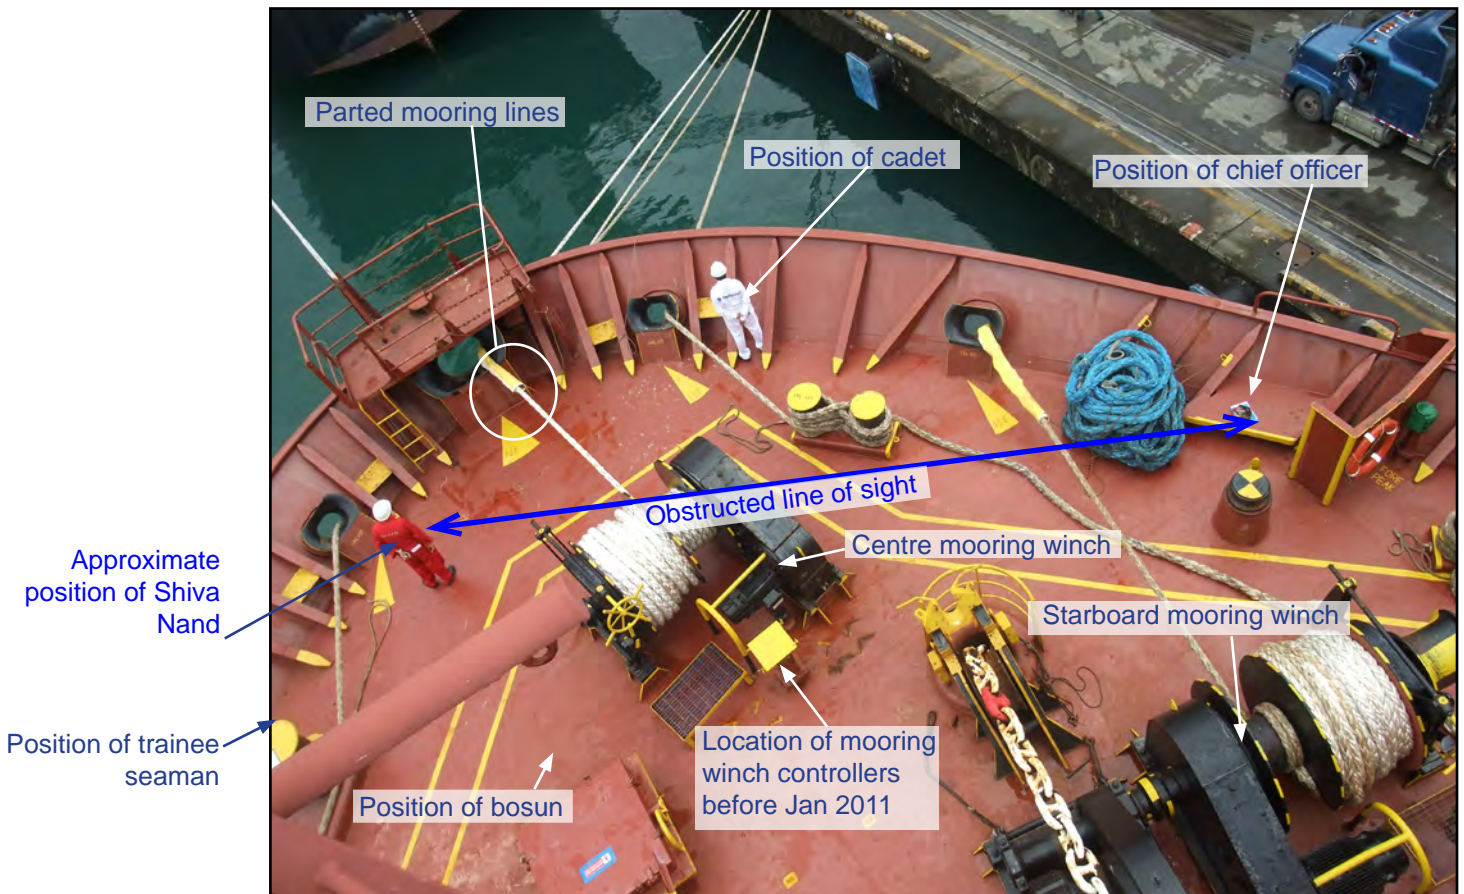
Figure 3

Reconstruction of forward mooring station

At 0955:21, the chief officer reported to the master that the headline had parted. The master enquired if anybody was injured. The chief officer's line of sight was obscured by the mooring winch (**Figure 3**) and he could not see Shiva. However, the bosun informed him that Shiva had been struck by the parted rope and had collapsed on deck. The chief officer promptly conveyed this to the master.

The forward mooring deck of *Fremantle Express* was spacious, with a designated walkway and snap-back zones clearly marked with yellow paint (**Figure 3**). The winch controllers had been positioned on deck, aft of the centre mooring

At the time of the accident, the chief officer was unable to monitor Shiva continuously as his line of sight to the OS was obscured by the central mooring winch (**Figure 3**). Had the bosun been operating the winch controls from the original, forward facing position, it is likely that he would have recognised that Shiva was entering a snap-back zone at a time when the headline was coming under tension and been able to provide a suitable warning to the OS and the chief officer.

The mooring winch controllers on the foredeck of *Fremantle Express* have been relocated to a position which affords the operator forward visibility.

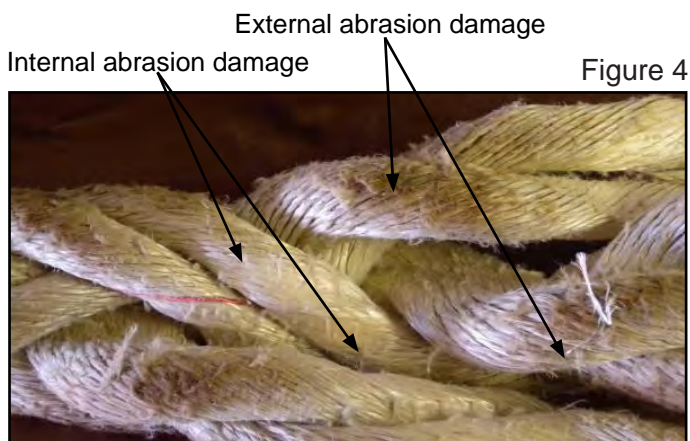
Following the accident, a representative sample (**Figure 4**) of the rope and the outboard section of the failure zone (**Figure 5**) were analysed by Tension Technology International Limited (TTI) to confirm the condition of the rope and establish the mode of failure. TTI concluded that:

1. The representative sample had lost a significant amount of strength, with an optimistic calculation giving a residual strength of 66% of its original strength.
2. The main cause of this strength loss was external abrasion damage.
3. The abrasion damage existed before the failure incident.
4. Internal abrasion damage contributed to the failure, but to a lesser degree.
5. The pre-existing external abrasion damage on the failure zone was worse than the representative sample.
6. It is possible that thermal degradation had occurred.

Representative sample of mooring rope taken 4 metres from the eye

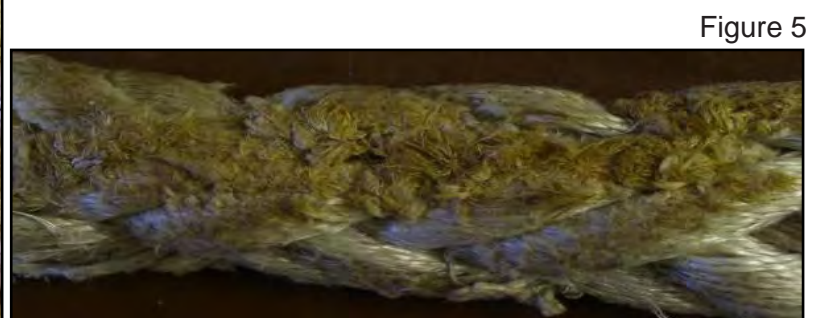
Section of the failure zone showing extreme abrasion damage

Records held on board *Fremantle Express* indicate that the ropes were inspected as required, and that some had been cropped when considered necessary. The mooring rope that parted had previously been cropped twice since being brought into service. Although its condition on 18 June 2011 was recorded as "satisfactory", the assessment made by TTI following the accident suggests that a lower standard of acceptability was being applied on board than that required in the company's instructions.

The accident could have been prevented had the company's retirement criteria been followed on board *Fremantle Express* and the damaged and degraded mooring rope been withdrawn from service.
