## IMCA Safety Flash 01/13

January 2013

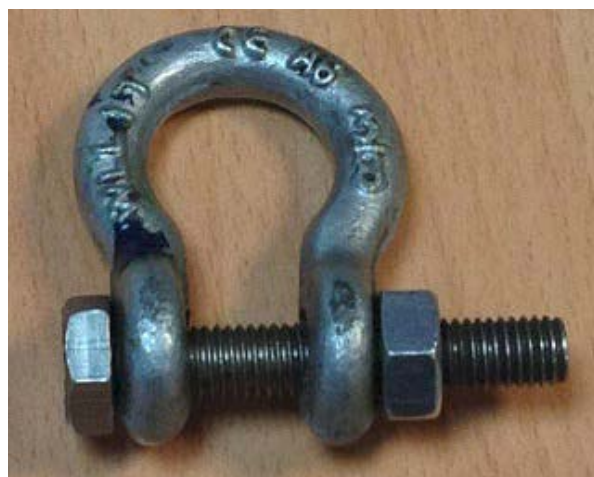
A member has reported finding shackles used for lifting equipment in an unsafe condition. A third-party lifting inspector was re-certifying lifting equipment when a 1 ton lifting shackle was discovered which had lost its pin, and the missing pin had been replaced with a standard bolt and nut which was not certified for lifting operations.

Additionally, the shackle was found to be pinched due to excessive pressure being applied when tightening the nut due to the bolt having thread along its entire length. It was not clear whether or not this shackle had been used for lifting but the potential for injury to personnel or damage to assets was high.

*Non-compliant shackle with nut and bolt  
(note shackle lugs pinched)*

- ◆ Lifting equipment should be fit for purpose and certified by a competent authority for use;
- ◆ Replacement or repair of lifting equipment invalidates the certification;
- ◆ Lifting equipment should be reviewed regularly for non-compliance and any non-compliant items taken out of service;
- ◆ Where damage is evident or pins/bolts are missing, the equipment should be removed from service and either destroyed or new parts ordered;
- ◆ If new parts are ordered, the lifting equipment should be re-tested with a certificate issued prior to return to service;
- ◆ Lifting equipment should follow the current colour coding;
- ◆ Lifting equipment colour codes should be well communicated and displayed;
- ◆ Identifying and reporting faults in lifting equipment is a regulatory requirement in many places and should be seen as a first line of defence.

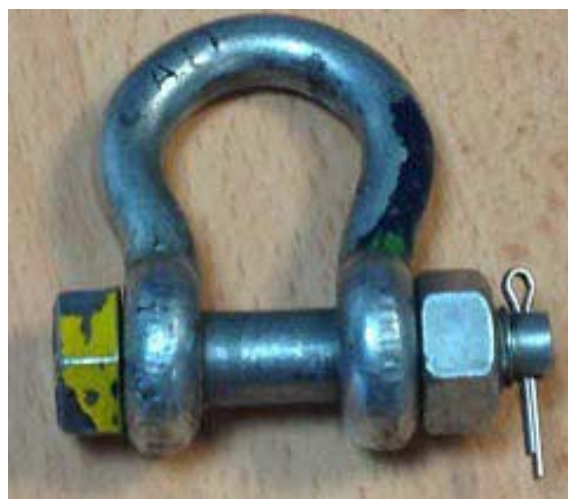
*Shackle with correct configuration and split pin  
(but colour code unclear)*

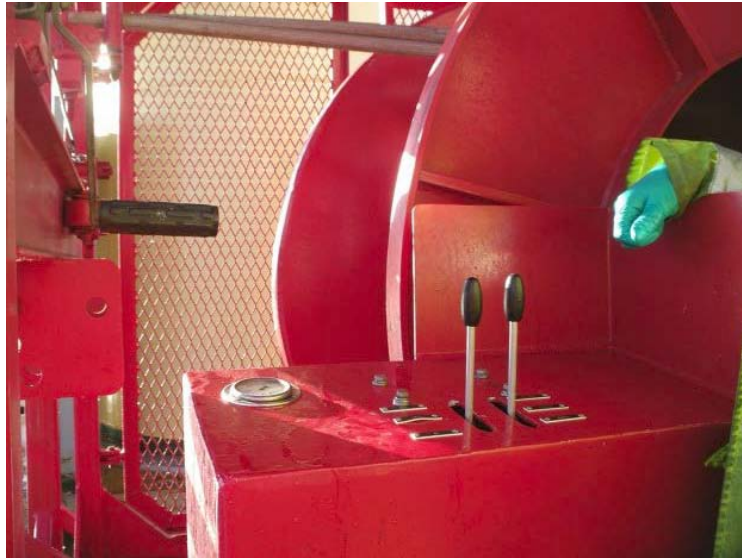
*Figure showing spooler arm and hydraulic spooler controls where injured person was standing*

- ◆ The vessel experienced a heave while the hydraulic hoses were being manually spooled/wrapped around a drum during grapple/pipe recovery operations;

- ◆ Insufficient slack left on the hydraulic hoses to accommodate the conditions/heave being experienced by the vessel led to the hoses becoming tight and the spooler arm handle to spin;

- ◆ Lack of recognition of a potential hazard (the spooler arm handle spinning if the hoses went tight) was such that there was no recognition of the need to ensure that sufficient slack was left on the hoses to avoid the handle spinning, or that body position during grapple recovery operations (if too close to the spooler arm handle) could potentially result in contact with it;

- ◆ The design/layout of the work area and location of equipment allows for hand/body positioning to get close enough to the spooler arm handle to make contact with it, in particular during times when vessel was experiencing a heave;

- ◆ Use of an automatic spooler would prevent the need for hand/body positioning so close to the spooler arm handle during recovery of the grapple;
- ◆ In addition to ergonomic issues, it was found that personnel were exposed to environmental hazards, i.e. the weather, when operating the controls. Adapting this area to include some form of habitat would mean operators were protected from the weather.

Additionally, a formal change was made to the launch and recovery operations process/task based risk assessment.

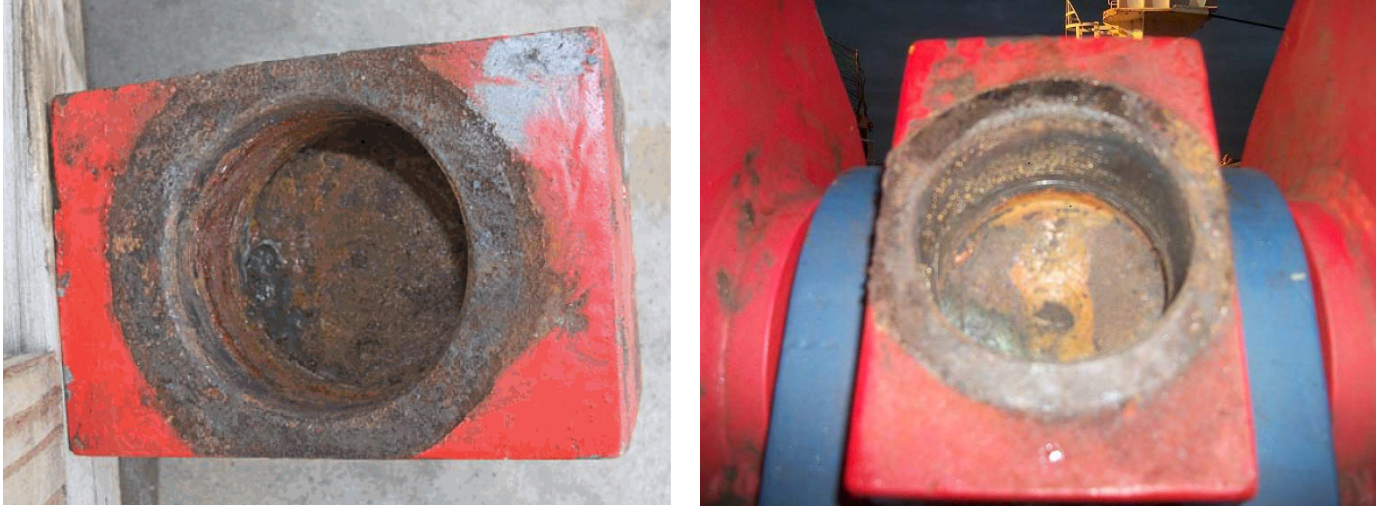
*Clevis pictured after failures*

- ◆ No evidence of anti-seize compound or other corrosion inhibitor in the rod end threads or on the rod threads;
- ◆ Dead space between rod eye and cylinder rod allows generation and collection of moisture/condensation.

- ◆ Excessive corrosion of each clevis (rod eye);
- ◆ Dimensional check shows clevis to be deformed.

The company notes that root cause analysis for multiple failures is on-going; however the causes of the corrosion are in part attributable to a missed step during the service and maintenance of the cylinders.

- ◆ Updated planned maintenance system with manufacturer's recommendations for inspection of cylinder rod eyes:
  - while A-frame foot is approximately 1" from the hard stop so the luff cylinders are in tension, use a feeler gauge to determine if there is any gap between the faces of the rod eye and rod. There should be zero gap. If there is a gap, the cylinder should be removed, rod eye removed and inspected
  - the counterbalance valves should be verified that they are adjusted properly
  - perform a visual inspection of the A-frame operation to focus on cylinder timing or excessive lateral movement
  - perform visual inspection of rod eye surface for excessive signs of corrosion at point of rod entry.
