Risk Focus: Moorings

With its team of risk assessors, the UK Club is in a unique position to gather data and target areas of risk onboard ship

Good condition of equipment - but worrying practices and procedures

In this article on mooring - the first of a series on current risk topics - we follow up on the Club's recent analysis of its mooring incidents. A twelve month exercise by the Club's in-house inspectors has produced important supplementary findings.

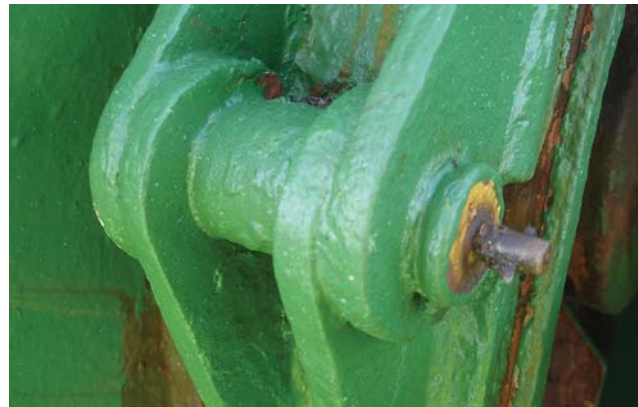
Ineffective grease point

painted over. To ensure that each point of the equipment is greased it may be beneficial to highlight or number each point and record the information in a plan.

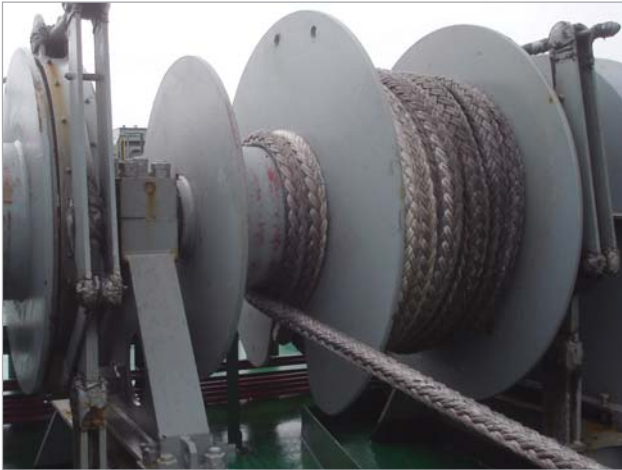
Correctly set up split drum

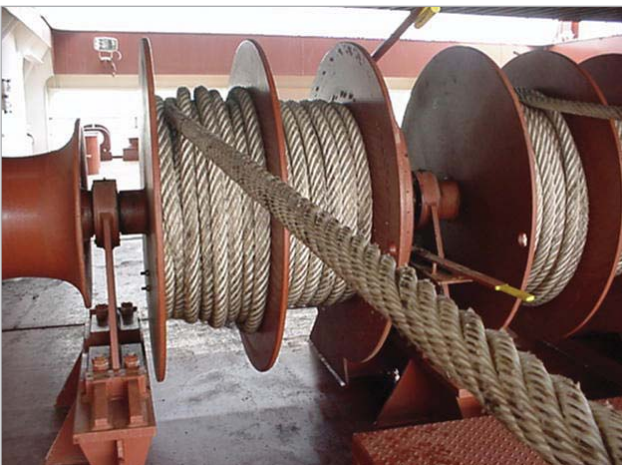
Despite the good overall winch condition, inspectors commented that on a number of vessels the split drums were not set-up correctly. The first picture below shows the correct way to set up a split drum, having only around 4 or 5 turns on the smaller drum and the remainder of the rope on the larger drum.

Incorrectly set up split drum with buried mooring line

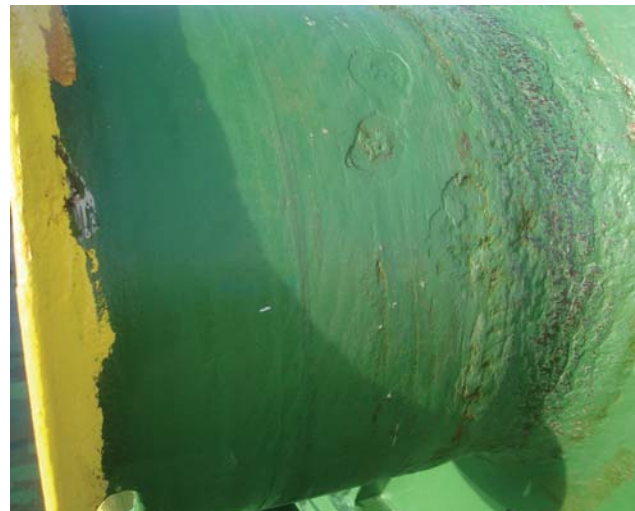
A further statistic showed that 94% of vessels had painted the drum ends. One hazard of over-painting is that the build up of paint on drum ends can cause rope damage. It is suggested that, if possible, drum ends should be smooth and coated with a thin layer of boiled linseed oil or other approved synthetic liquid for protection.

Build up of paint on the drum end

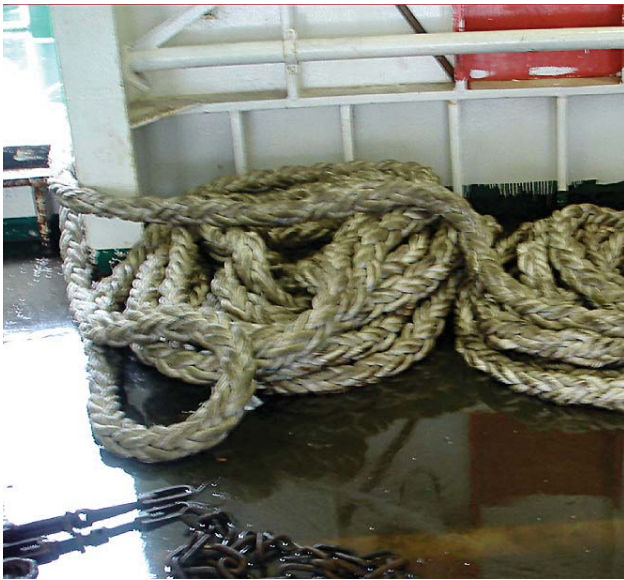
Ropes badly stored on wet deck

wires and links should not be over stowed with paint, chemicals, or any other shipboard or general cleaning items. Spare mooring equipment should be stowed clear of the deck, preferably on a pallet and in a dry ventilated position. If mooring ropes and wires are stowed on deck during sea passages they should not be exposed to sunlight, sea spray or funnel soot. It is suggested that canvas or heavy duty polyethylene covers will prolong the life of the ropes/wires.

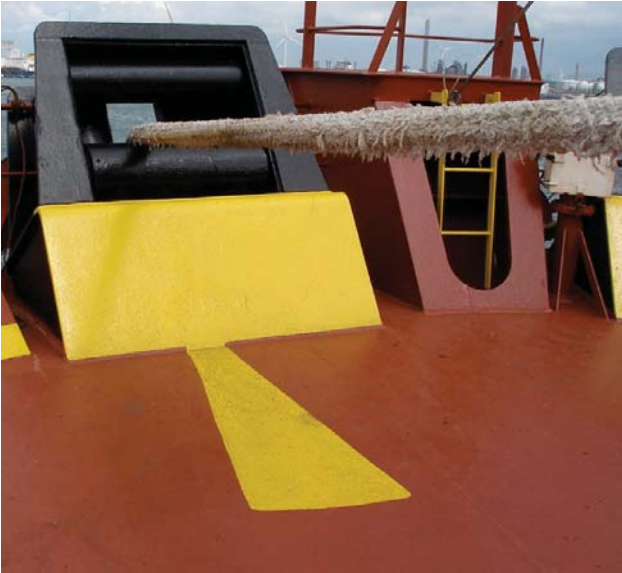
Clearly marked snap-back zone

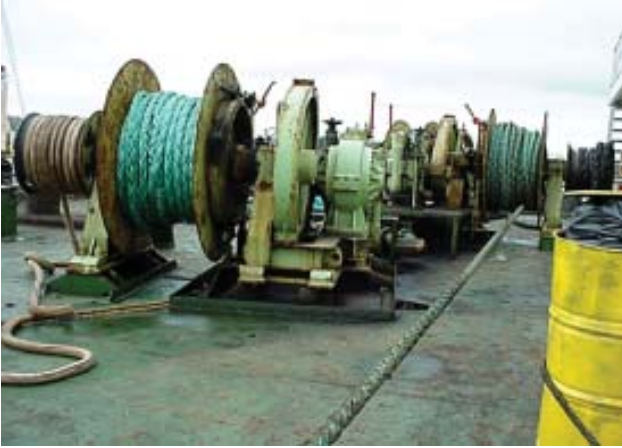
Poor and potentially unsafe mooring area example

Unfortunately this photo illustrates a sight sometimes experienced by the UK Club ship inspectors. Not only are the windlasses rusty and poorly maintained, but the mooring area as a whole suggests poor safety and maintenance standards on board:

- The mooring area is dirty and all surfaces are in need of maintenance.
- All surfaces are painted the same colour, hiding trip hazards such as save-alls, windlass platforms, forecastle access hatch and bits.
- There are no hazard highlightings or warning markings.

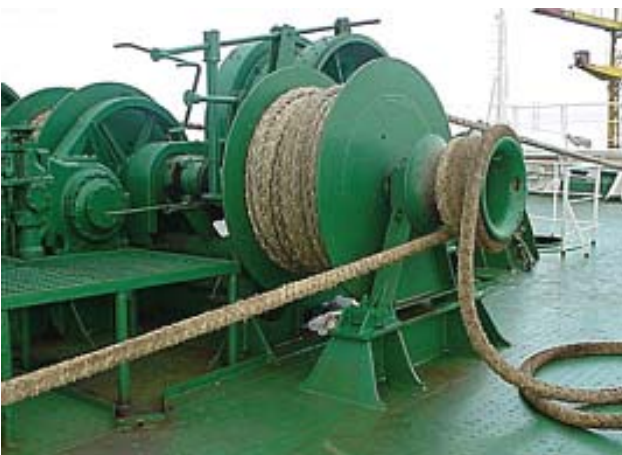
Well painted but poorly highlighted mooring station

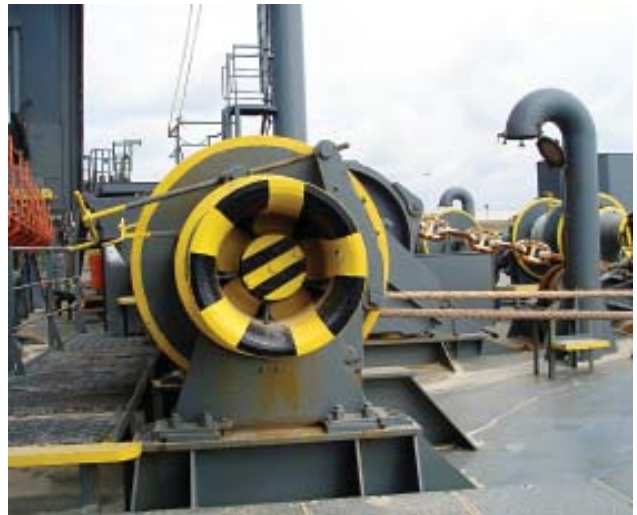
Mooring station with effective hazard markings

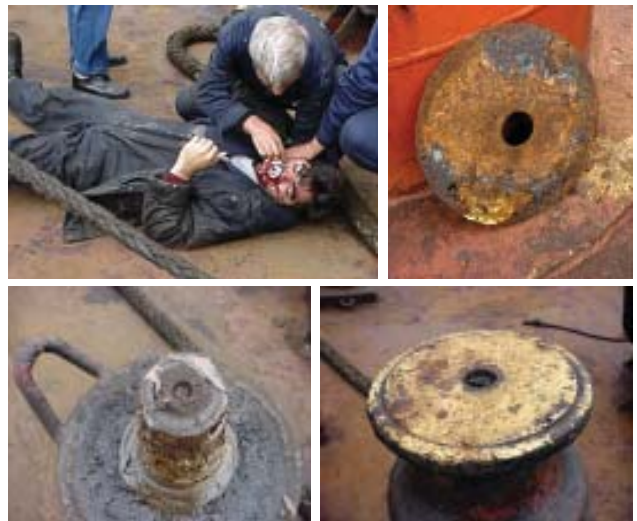
An A/B was seriously hurt when a roller fairlead detached from its pedestal whilst under the influence of a mooring line under tension. The A/B was standing in the snap-back zone and was struck by the rope, which hurled him into the foremast causing head injuries.

The rope hurled the roller fairlead 20 feet from the ship to the quayside.

The angle or directional lead of a rope should be considered when using leads in order to prevent incidents like this. But this particular incident also highlights the importance of proper maintenance of mooring equipment.

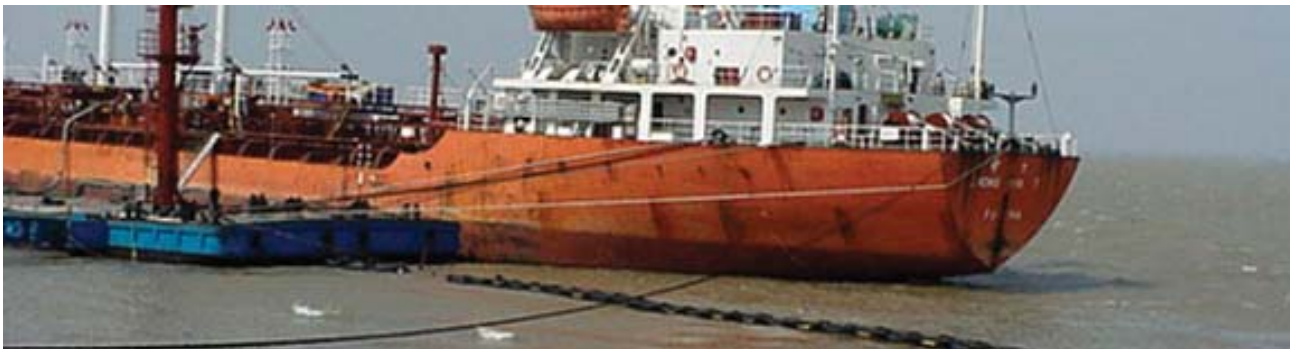
The image below shows a vessel considerably overhanging her berth. She is therefore unable to lead any stern lines aft of the ship. The image shows one line in particular being lead an extremely long distance, rendering it pretty much useless.

The ship has correctly put out as many lines as possible but should also consider the use of the anchor and mooring lines running aft from either the main deck or other suitable areas. In situations like this it is important to analyse local tidal and weather patterns in order to predict how the vessel will be affected. The vessel owners should be informed and cargo operations stopped (or not commenced) if conditions do not appear safe.

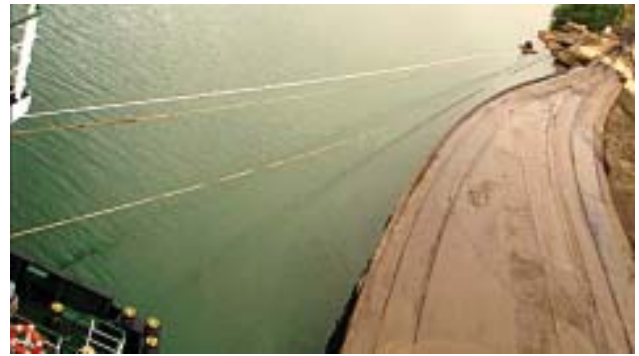
The following image shows insufficient mooring arrangements ashore and the vessel is forced to pay out an extremely long lead on the stern lines. In this event, the master should protest to the port authority, take photos and inform the owners.

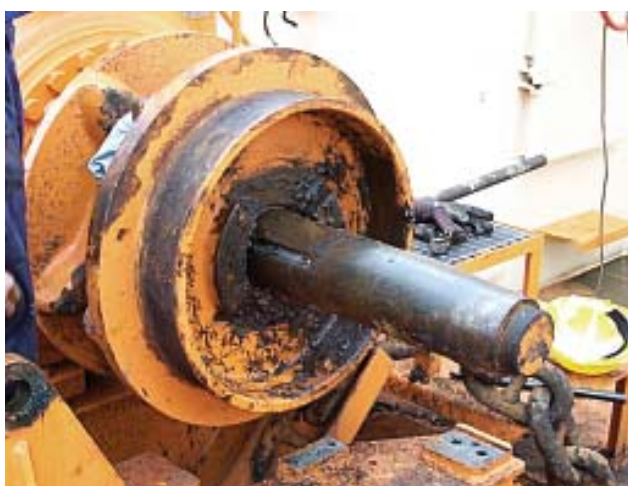
Windlass drums are not designed for taking the weight of mooring lines for a long period of time. If windlass drums are used for this purpose then over a period of time they will suffer damage and be in need of repair.

This windlass drum suffered bearing damage and is being overhauled

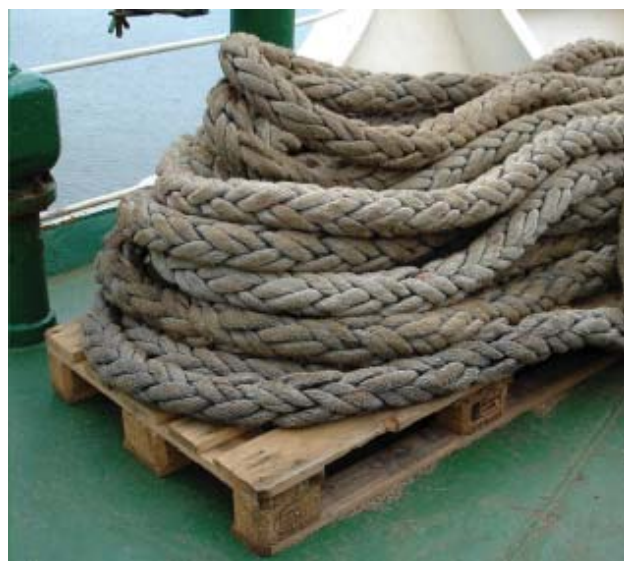
Ropes correctly stowed off deck

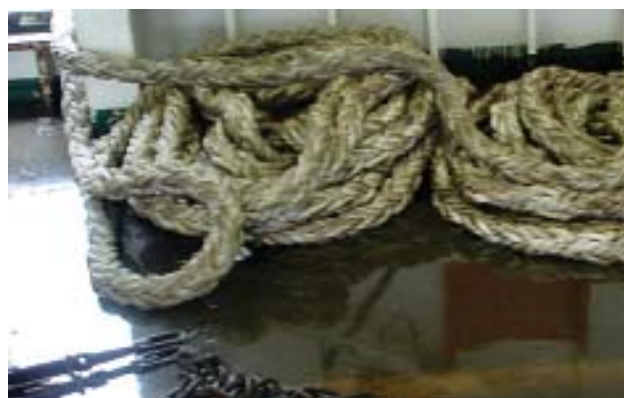
Ropes badly stored on wet deck

stowed off the deck and if possible away from precipitation and direct sunlight. If baskets or other storage devices are not available then ropes should be coiled down on pallets (see below).
