MV ANTONIS

Contact with Langton-Alexandra swing bridge In the Port of Liverpool 11 December 2010

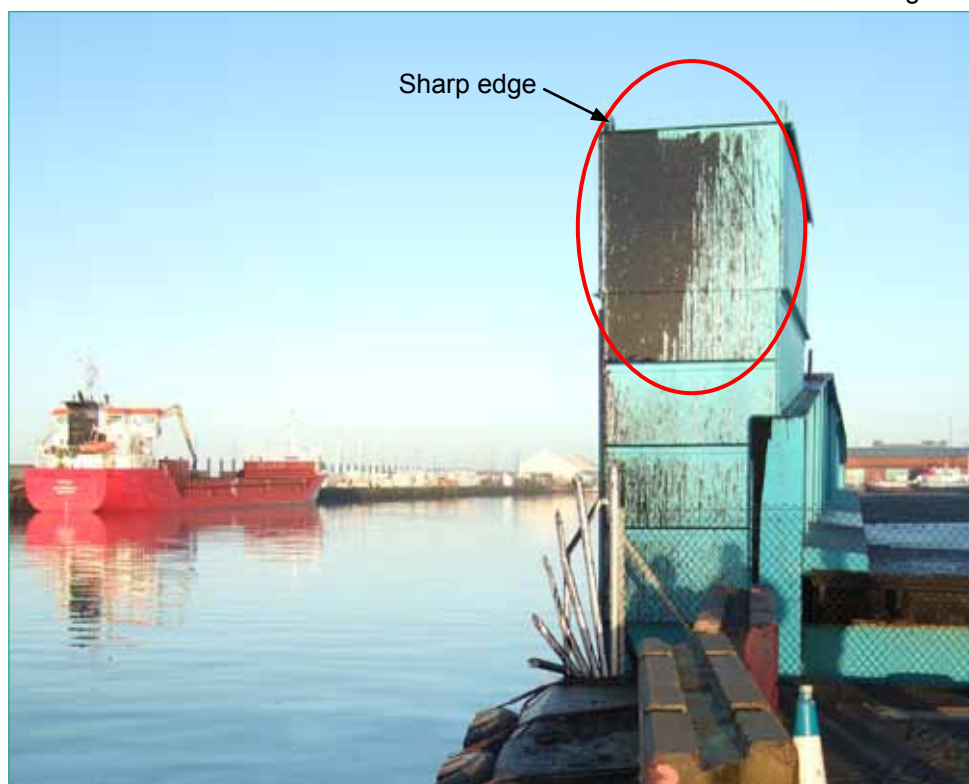
Figure 3

Swing bridge showing counterweight

tug's master. The pilot also ordered the helm 'hard-a-port'. However, these actions did not prevent the vessel's hull from making contact with the sharp edge of a counterweight ballast tank fitted on the open and recessed swing bridge (**Figure 3**).

completed in April 2008. To compensate for the increased length of the swing bridge, a rectangular counterweight was fitted (Figure 3). The extension to the bridge resulted in its end overhanging the northern end of the eastern wall inside Alexandra Dock when in a stowed position. This made it vulnerable to contact from passing traffic (Figure 6).

Even though the swing bridge was open and recessed, *Antonis* was able to make contact with the sharp corner of its counterweight (**Figure 3**) due to the hull overhang in the area of No 5 (P) fuel oil tank.

Prior to the accident, the port authority had not identified the counterweight as being a potential hazard to vessels using the passageway.

2. Prior to the accident, the port authority had not identified that the counterweight on the refurbished bridge posed a hazard to vessels using the passageway.

- Has increased the fendering on the western wall.
- Intends to install low level indicator lights to assist in locating the waterline within the passageway.
- Intends to discuss with the tug companies possible improvements to the fendering on the south side of the eastern wall.
- Intends to improve the fendering in the passageway and protection to the bridge end.
- Intends to discuss with the pilotage services company how the use of the third tug can be optimised to enhance pilots' control of the manoeuvre through the passageway.
- Intends to complete a formal risk assessment for vessels transiting the dock system.

2011/118 Expedite measures planned which are designed to improve the safety of vessels using the Langton-Alexandra passageway.

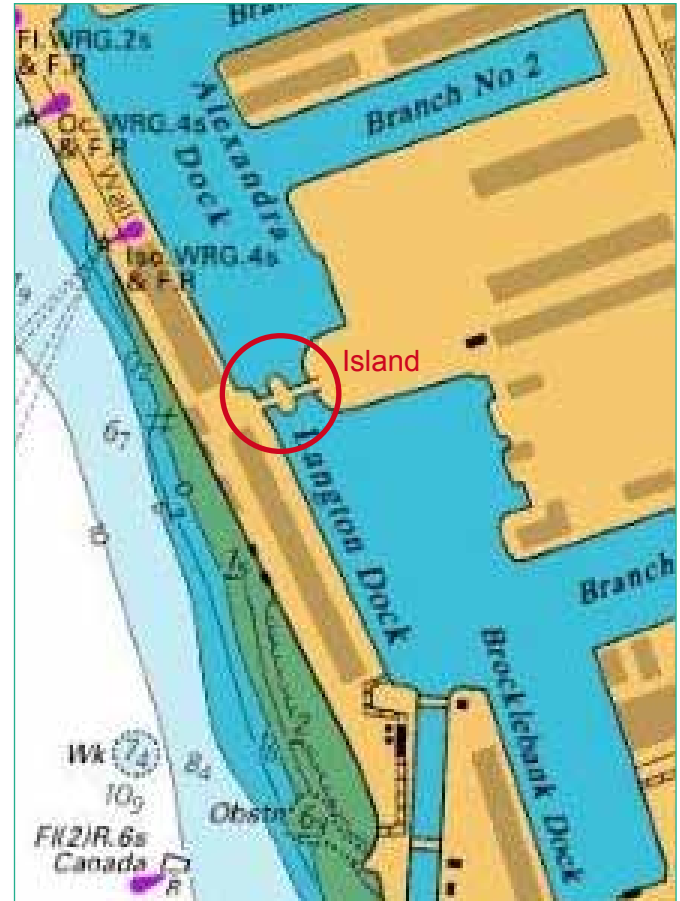
Figure 5

Work to widen the passageway from 27 to 39.46 metres (Figure 5) was completed in September 2006 when the passageway was re-opened to traffic. In April 2007, the swing bridge was lifted out to be refurbished and lengthened. This work was

Langton-Alexandra passageway
