## FV KAREN

### Grounding at the Entrance to Ardglass Harbour, County Down, Northern Ireland 3 January 2011

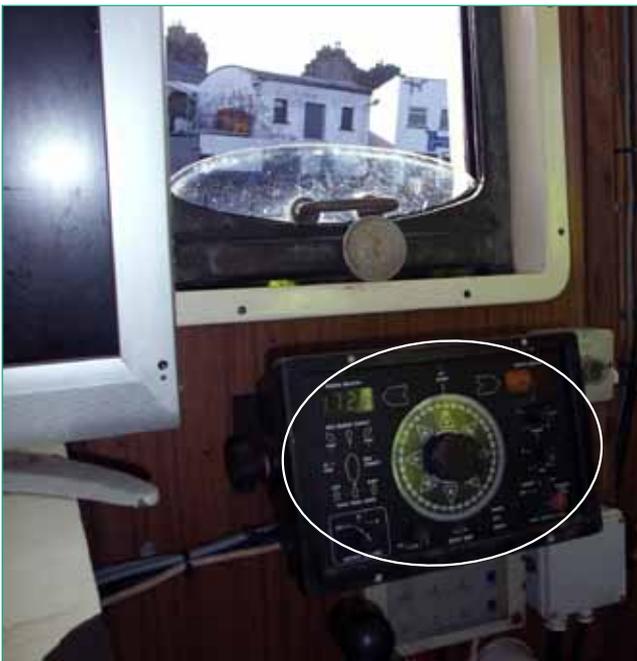
Figure 2

During the latter stages of the passage, the skipper reportedly opened and leaned out of the wheelhouse starboard window, which was positioned directly above the autopilot (**Figure 2**), to speak with a crewman on deck. At about 1755, the vessel grounded on the northern side of Ardglass Harbour. The impact caused the crewman to fall onto a rail, resulting in bruising to his ribs. There were no other injuries. The skipper's estimated grounding position and other key navigational marks are shown in **Figure 3**.

Position of autopilot in relation to the wheelhouse starboard window

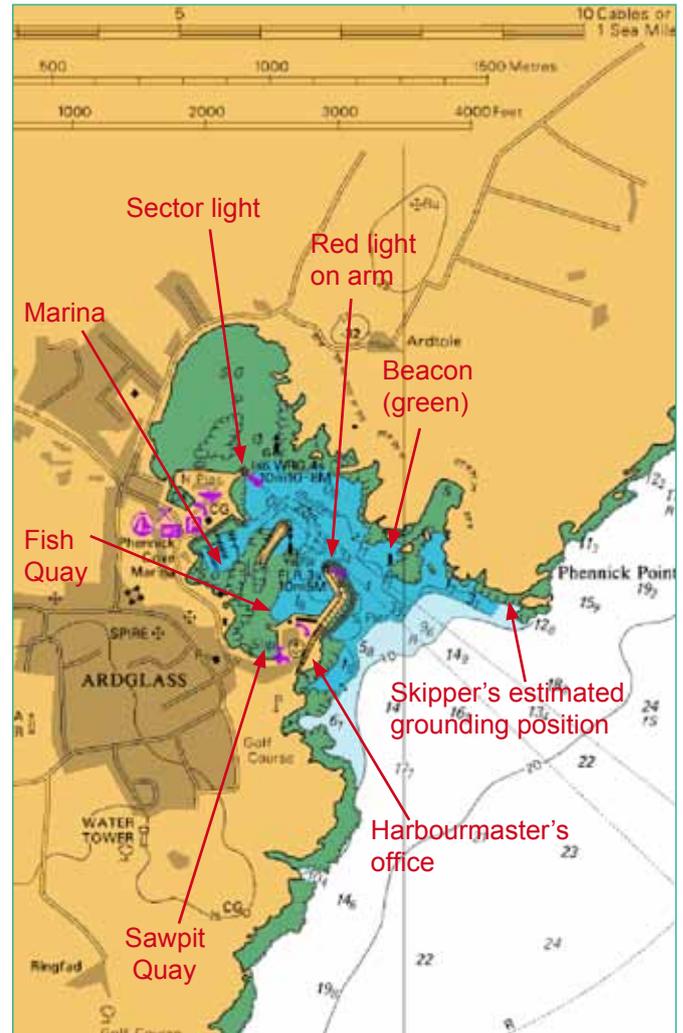
Figure 3

Skipper's estimated grounding position and key navigational marks

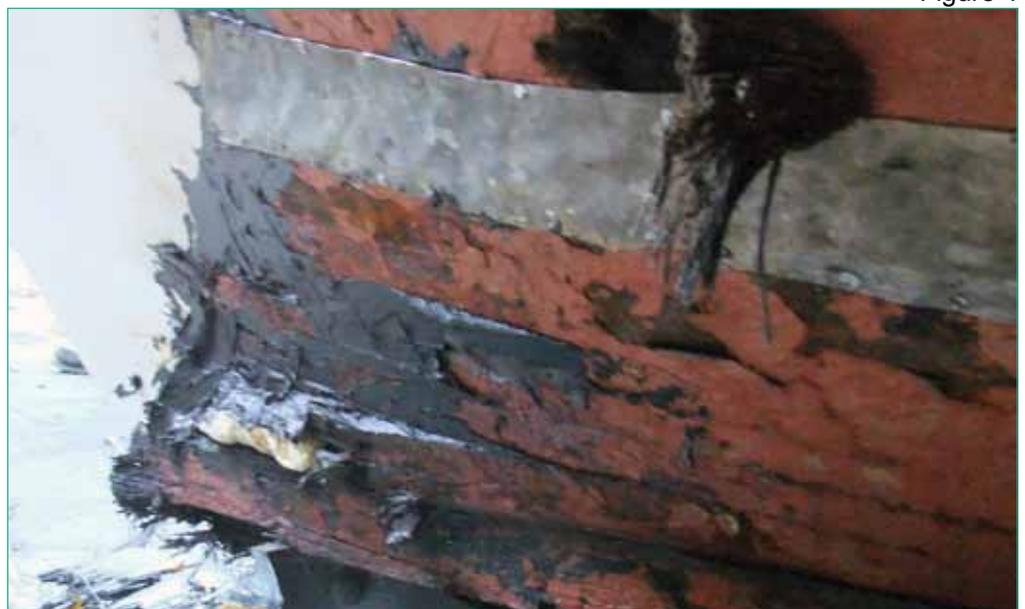
Figure 4

Damage to the vessel was limited to the foot of the stem post (**figure 4**), where some planking had also sprung causing the caulking to become displaced. There was also abrasion damage to the hull on both sides at the turn of bilge.

Stem post damage

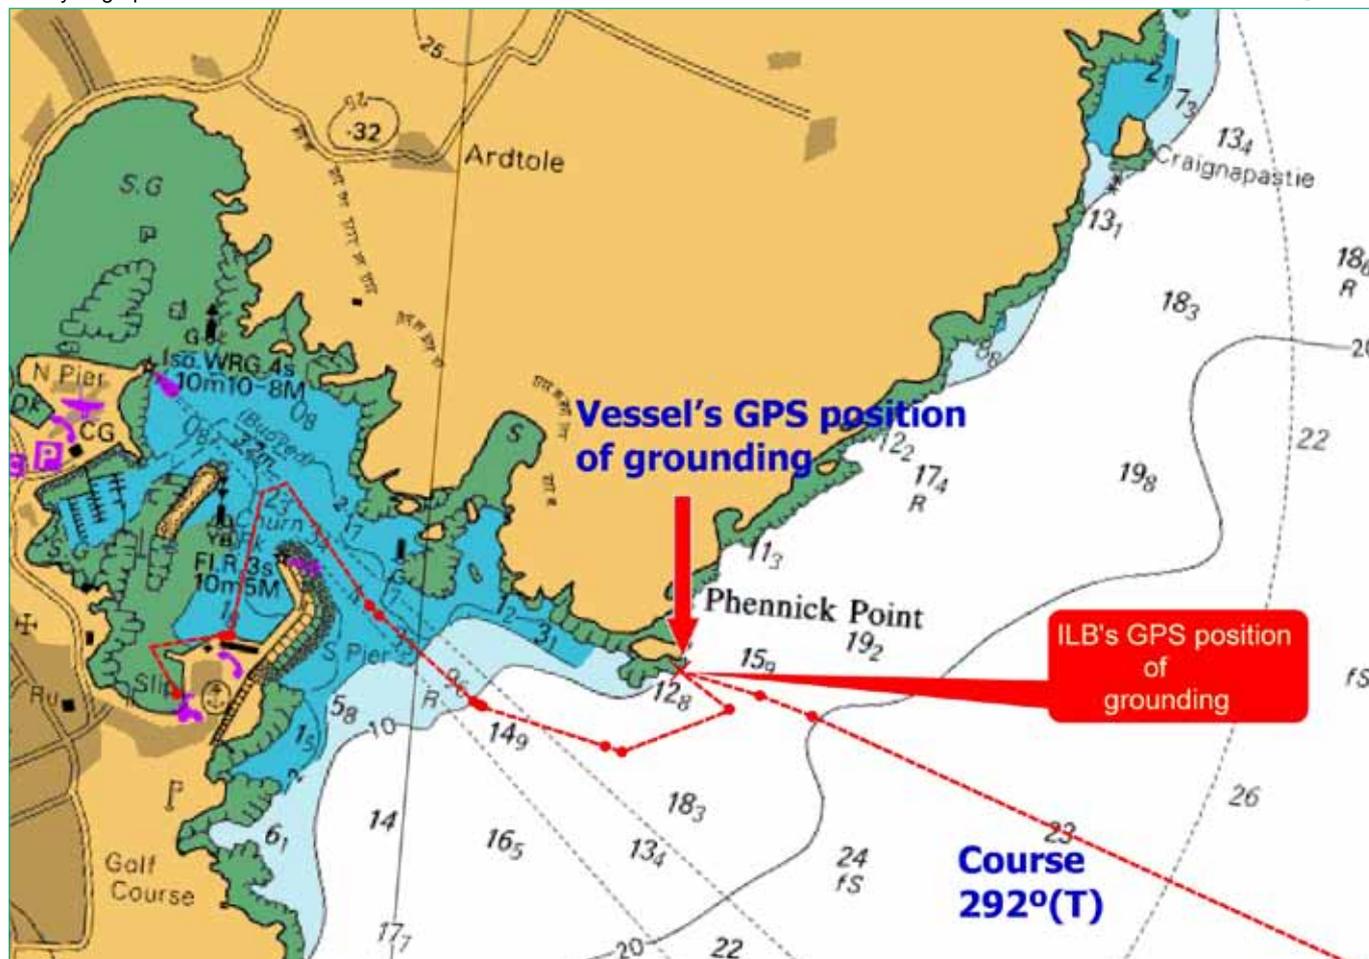
Figure 5

Data downloaded from *Karen's* GPS unit confirmed that she was making a generally steady course of 292°(T) until grounding at Phennick Point in position 54°15.613'N, 005°35.693'W (Figure 5). The grounding position was confirmed from the ILB's GPS, though the skipper estimated

GPS track and grounding position

the vessel had grounded closer to the harbour. There was no evidence to support a suggestion that the autopilot might have been inadvertently adjusted to starboard just prior to the grounding when the skipper reportedly leaned out of the wheelhouse starboard window to speak with a crewman on deck.
