Understanding mooring incidents

Major accidents involving mooring equipment in the last 20 years have injured many seafarers and have cost the UK Club over US\$34 million

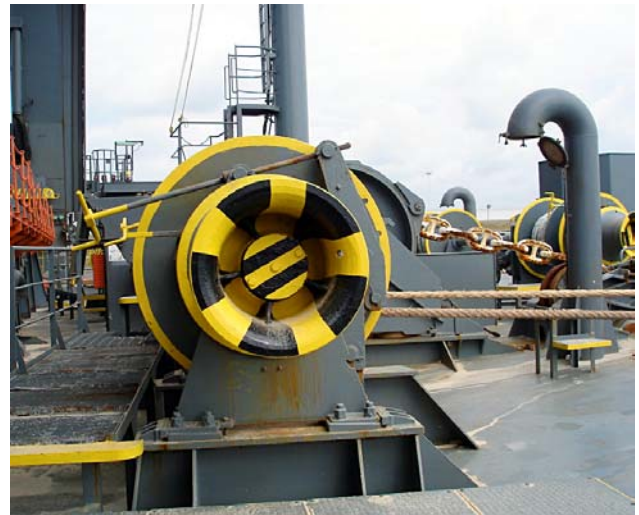
Mooring station with effective hazard markings

The following images illustrate how effective hazard highlighting can be, when compared with a mooring station that is simply well painted.

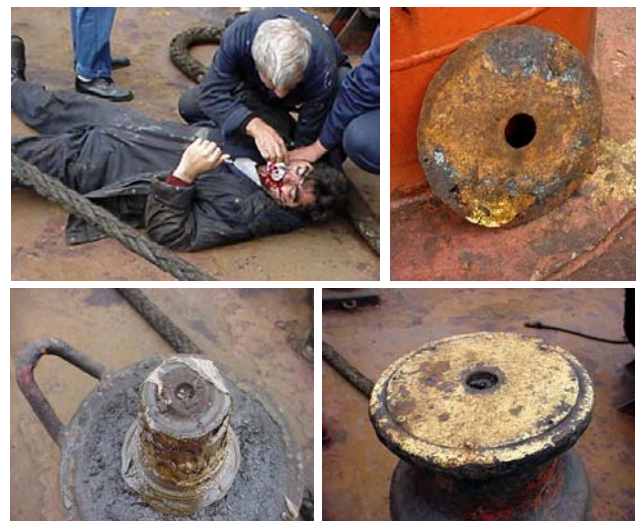
An A/B was seriously hurt when a roller fairlead detached from its pedestal whilst under the influence of a mooring line under tension. The A/B was standing in the snap-back zone and was struck by the rope, which hurled him into the foremast causing head injuries.

The rope hurled the roller fairlead 20 feet from the ship to the quayside.

The angle or directional lead of a rope should be considered when using leads in order to prevent incidents like this. But this particular incident also highlights the importance of proper maintenance of mooring equipment.

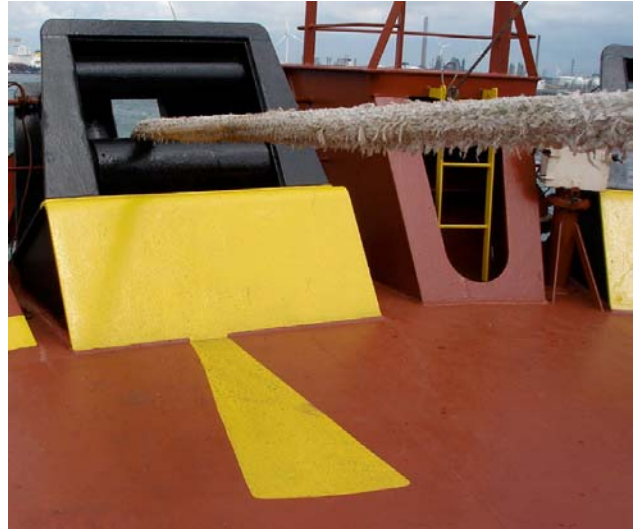
The image (left) shows a pedestal fairlead that is well maintained. There is evidence that it has recently been turned and greased and the grease nipple on top is highlighted.

Mooring equipment that has suffered severe wastage will not perform to the certified standard. This also applies to the steel to which the equipment is welded. The image shows mooring bits that are badly wasted. The deck is in equally bad condition and there is a danger of the bits being torn from the deck.

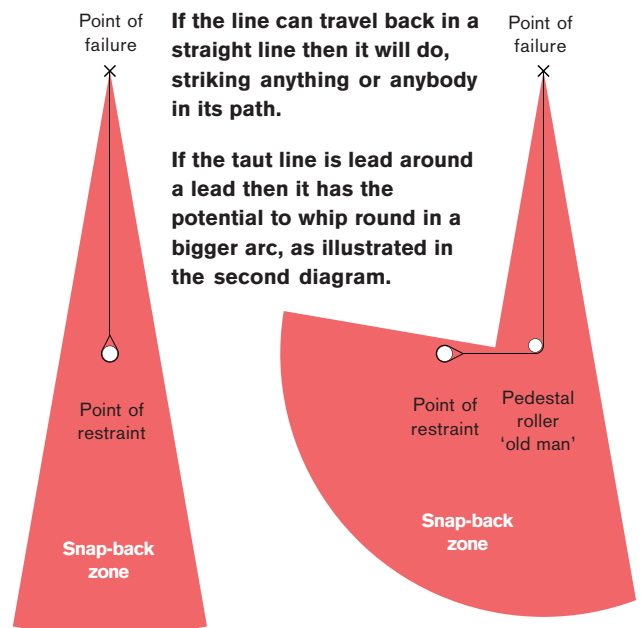
When a line under tension parts, it will whip back to the remaining point of tension.

If snap-back zones are painted on the deck then crew will be alerted to the danger when they notice they are standing in a highlighted zone.

Highlighting mooring line snap-back zones ensures that crew can visibly see the danger areas without having to purposely think about them while working.

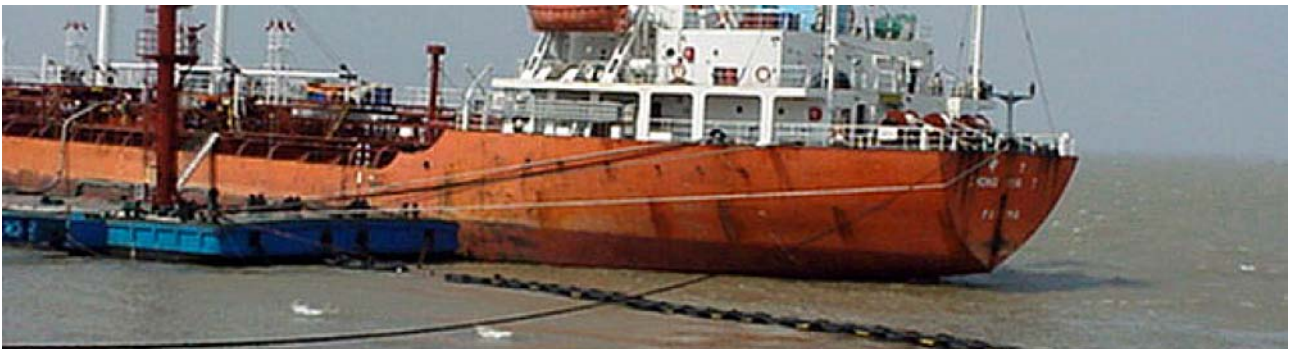
The image below shows a vessel considerably overhanging her berth. She is therefore unable to lead any stern lines aft of the ship. The image shows one line in particular being lead an extremely long distance, rendering it pretty much useless.

The ship has correctly put out as many lines as possible but should also consider the use of the anchor and mooring lines running aft from either the main deck or other suitable areas. In situations like this it is important to analyse local tidal and weather patterns in order to predict how the vessel will be affected. The vessel owners should be informed and cargo operations stopped (or not commenced) if conditions do not appear safe.

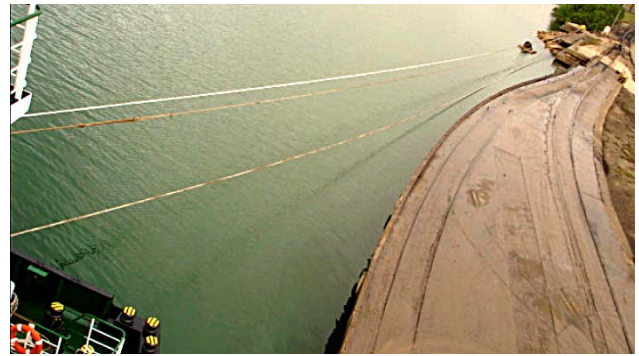
The following image shows insufficient mooring arrangements ashore and the vessel is forced to pay out an extremely long lead on the stern lines. In this event, the master should protest to the port authority, take photos and inform the owners.

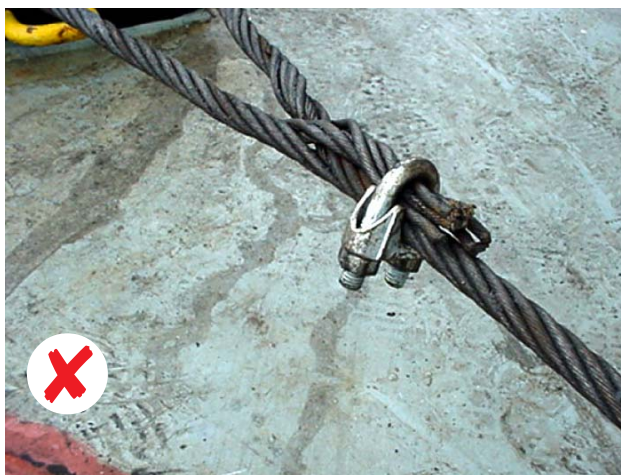
- An allowance of 150 mm should be made between the last bulldog grip and the end of the 'dead' wire. It is important to ensure that the lashing wires are not cut short immediately next to the bulldog grips.

- Bulldog grips have a grooved surface in the bridge piece which is suitable for a standard wire of right-hand lay having six strands. Crosby grips have a smooth surface in the bridge piece. The grips should not be used with ropes of left-hand lay or of different construction.
- The first grip should be applied close to the thimble or at the neck of the eye if a thimble is not used.

Other grips should be placed at intervals of at least one clear grip (albeit a distance of six rope diameters apart is suggested) between each other.

- The grips must all face in the same direction and must be fitted with the saddle or bridge applied to the working or hauling part of the rope. The U-bolt must be applied to the tail or dead-end of the rope. If the grips are not applied as indicated above, the effectiveness of the eye can be seriously affected.

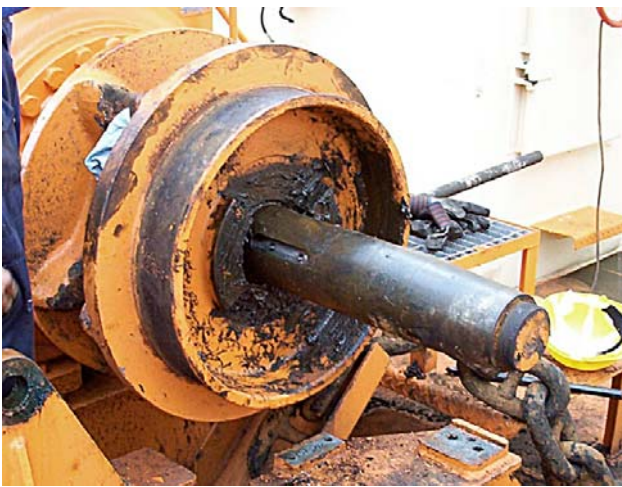
This windlass drum suffered bearing damage and is being overhauled

Windlass drums are not designed for taking the weight of mooring lines for a long period of time. If windlass drums are used for this purpose then over a period of time they will suffer damage and be in need of repair.

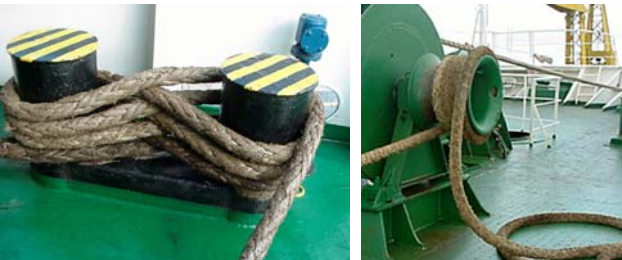
Once ropes have been hauled tight they should be secured to bitts as in the good example on the left

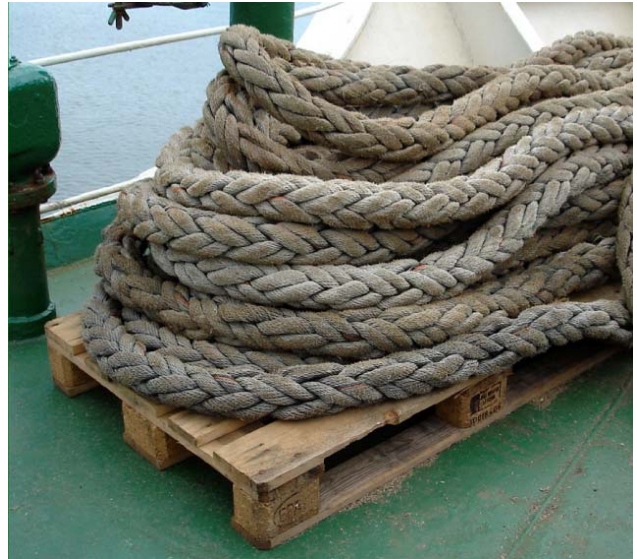
Ropes correctly stowed off deck

stowed off the deck and if possible away from precipitation and direct sunlight. If baskets or other storage devices are not available then ropes should be coiled down on pallets (see below).

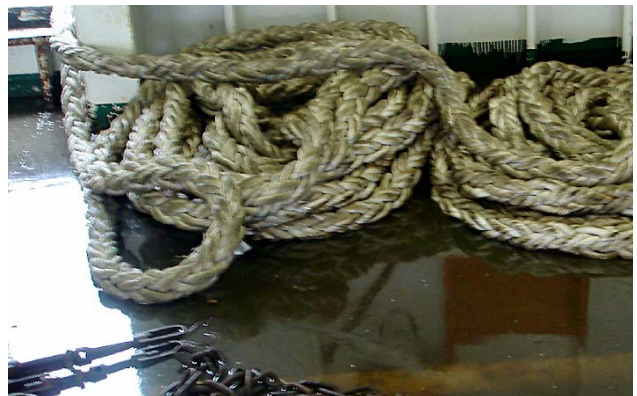
Ropes badly stored on wet deck
