MV FREMANTLE EXPRESS

Fatality during mooring operation

Veracruz (Mexico)

15 July 2011

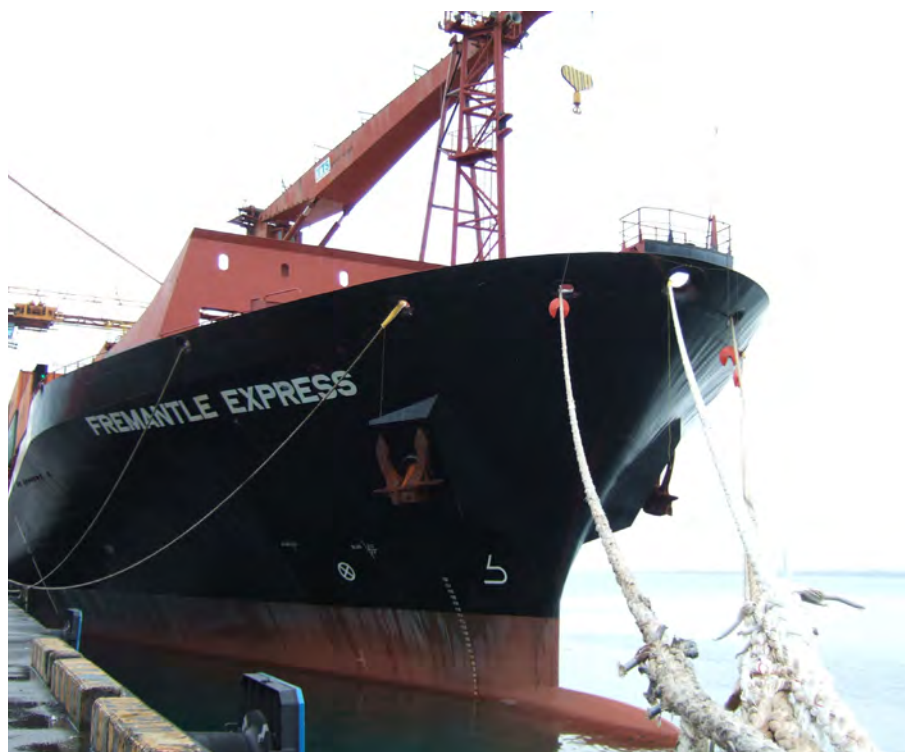
Figure 1

At 0942, the vessel approached her intended berth assisted by the two tugs, and the aft backspring was sent ashore. At 0944, the master instructed the chief officer to send the forward lines ashore. The cadet was tasked with throwing a heaving line to the mooring gang ashore while the trainee seaman and Shiva tended the lines. The bosun, facing aft, operated the winch controllers and took instructions from the chief officer who was standing on the starboard observation platform (**Figure 1**).
