Risk Focus: Moorings

With its team of risk assessors, the UK Club is in a unique position to gather data and target areas of risk onboard ship

Good condition of equipment - but worrying practices and procedures

In this article on mooring - the first of a series on current risk topics - we follow up on the Club's recent analysis of its mooring incidents. A twelve month exercise by the Club's in-house inspectors has produced important supplementary findings.

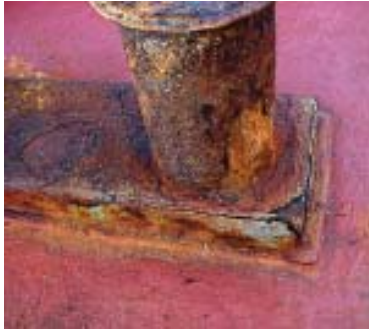
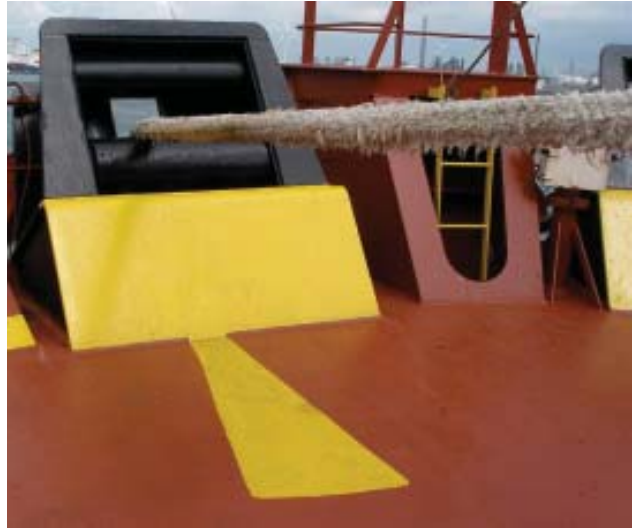
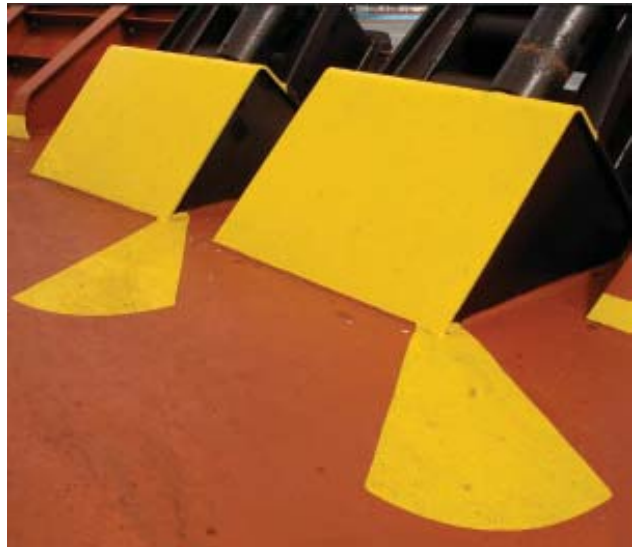
Mooring equipment that has suffered severe wastage will not perform to the certified standard. This also applies to the steel to which the equipment is welded. The image shows mooring bits that are badly wasted. The deck is in equally bad condition and there is a danger of the bits being torn from the deck.

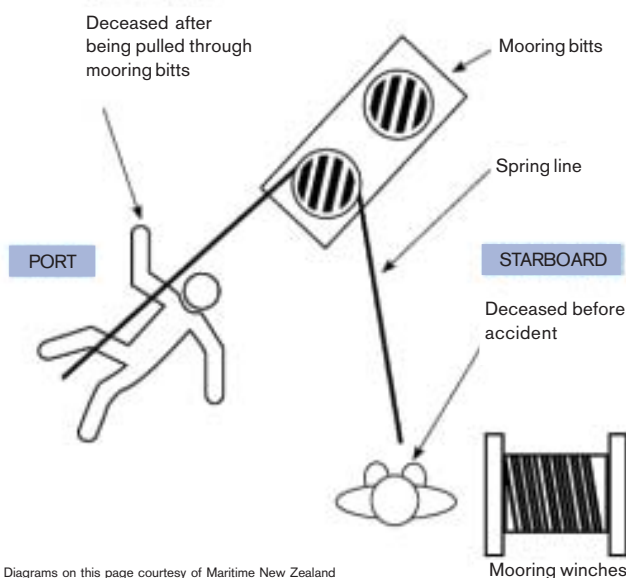
The diagram forms part of an investigation report into the death of an A/B who was dragged through a set of bits by a mooring line.

This incident also highlights procedural and awareness issues because the mooring party forward informed the bridge that all lines were clear when they were in fact still in the water. Nobody noticed that as the vessel was manoeuvring away from the berth, one of the lines became snagged on one of the wharf buttresses.

The unfortunate seaman was recovering the line but stepped in a bight of the mooring line as it became taut and was then dragged through the bits as the fouled line ran from the vessel.

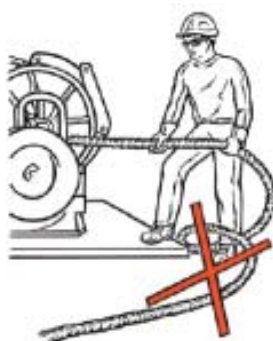
Bights don't always look like bights. Here a seaman has inadvertently stepped over the line and put himself at risk

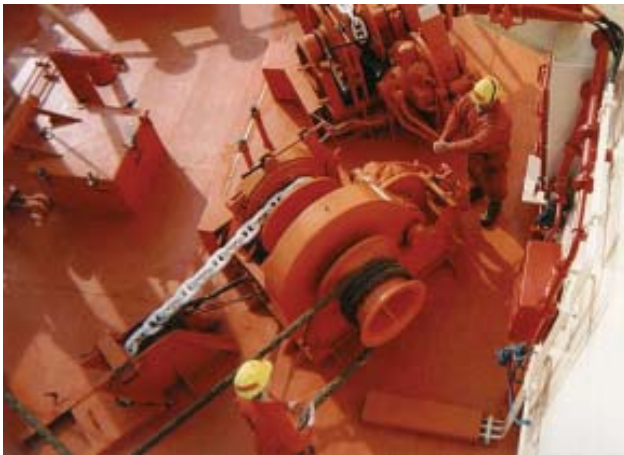
Mooring operations should be conducted in a safe manner. In the image below:

- The line on the windlass drum is being handled safely. The crewmember at the drum is keeping his hands clear of the turns and positioned so as not to become fouled in coils of rope.
- The crewmember operating the windlass has a good line of sight of the rope and the man handling it.
- Both crew are appropriately attired in correct personal protective equipment.

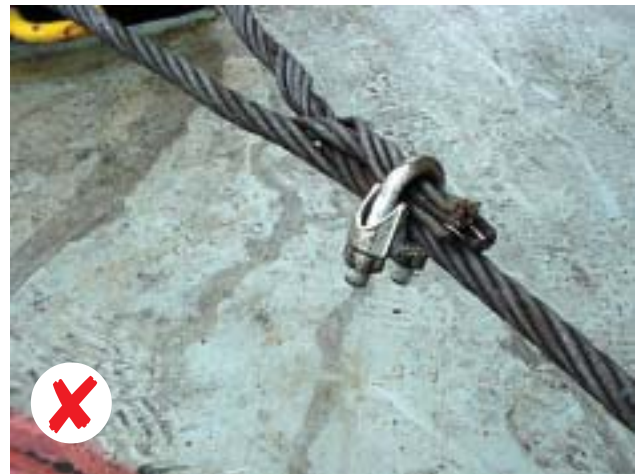
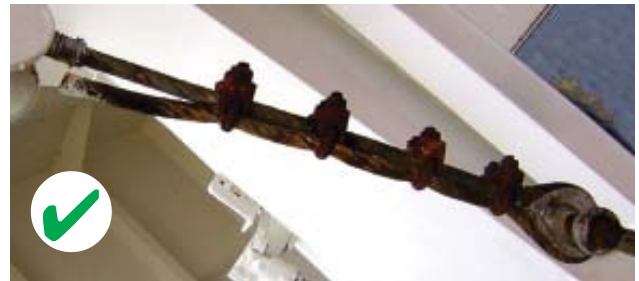
- An allowance of 150 mm should be made between the last bulldog grip and the end of the 'dead' wire. It is important to ensure that the lashing wires are not cut short immediately next to the bulldog grips.

- Bulldog grips have a grooved surface in the bridge piece which is suitable for a standard wire of right-hand lay having six strands. Crosby grips have a smooth surface in the bridge piece. The grips should not be used with ropes of left-hand lay or of different construction.
- The first grip should be applied close to the thimble or at the neck of the eye if a thimble is not used.

If it is necessary to create an eye in the end of a wire, then it would be worth investing in crimping equipment. Many ships prefer the use of bulldog-grips for creating an eye in the end of a wire rope, but there is a correct way of doing this:
